# UNIVERSITY OF MUMBAI

A Safety Analysis Report

# Mumbai University

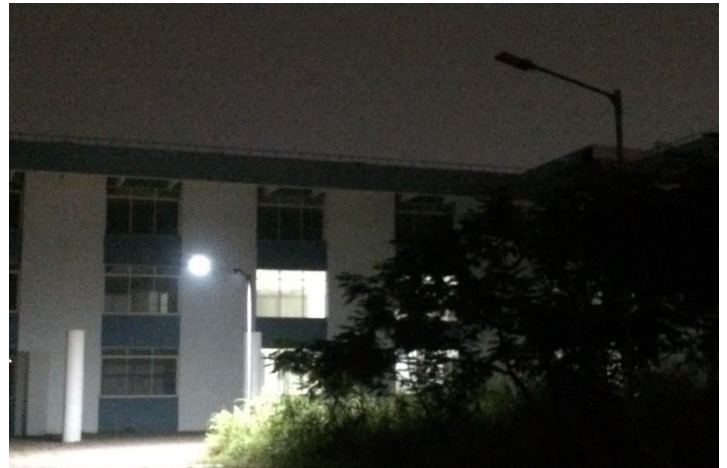
*Image showing an audit location with non functional streetlight.*

The streetlights in the Mumbai University Campus needs to be checked and maintained regularly to ensure adequate illumination levels. Streetlights need to be installed along areas, identified as dark spots i.e. at these locations there is no illumination at present.

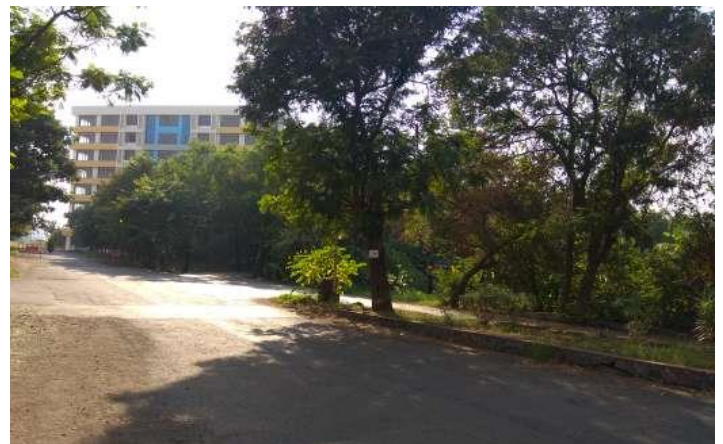
*Image showing an audit location with no footpath*

At certain locations, the pavement was found to be broken. This needs to be repaired and a proper paved surface should to be created. Along certain roads either no footpath exists or space has been left for one but it hasn't been constructed. A proper footpath needs to be constructed, free of any obstruction. Also provision should be made to ensure smooth movement of people with any form of disability.

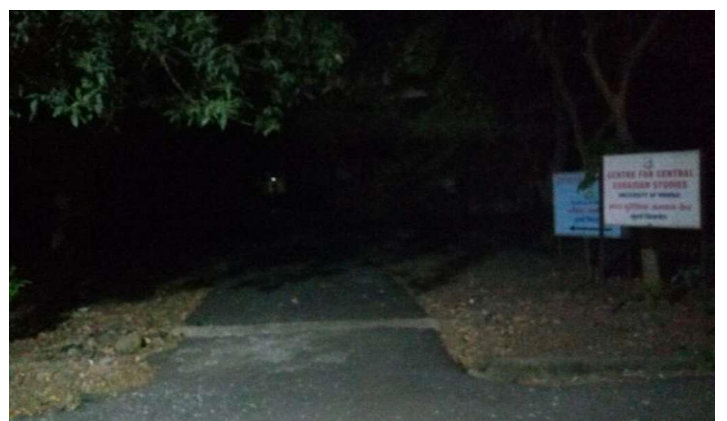
Visibility has been rated as Poor or Below Average in many areas in the project site. The auditors have reported that there are few stretches which are completely isolated. Efforts should be made to make such stretches active. Security in such areas should be improved by increasing patrolling through security guards.

*Image showing an audit location with Poor visibility*
